**Trihasco** **Utama**  
Inspection and Engineering company

# "Inspeksi, Assessment, Re-Engineering dan Sertifikasi Tangki Penimbun."

#### ASSESSMENT TO API STD 653

Current conditions of STORAGE TANK T-04 SP5 Kawengan was presented in the following table.

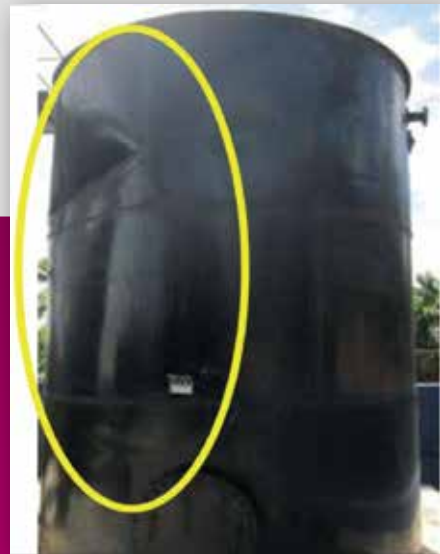
Generally the STORAGE TANK T-06 SP3 was NOT good condition and NOT fit for service as per the following parameters:

There was significant anomaly found during inspection that might affect the ability of the storage tank to continue safe operation.

It is recommended to repair the tank conditions to stay in fit for services as the following recommendations:

- Perform rectification on spot settlement which out-of-tolerance.
- Repair the roof plate due to 90% hollow based visual inspection
- Repair the shell plate due to seepage based result visual inspection
